15
National Dam Inspection Program.
Tyrone Reservoir 2 (NDI 535)
Susquehanna River Basin, Sink Run,
Blair County, Pennsylvania. Phase I
Inspection Report.

PHASE I REPORT
NATIONAL DAM INSPECTION PROGRAM

NAME OF DAM: Tyrone Reservoir No. 2
STATE LOCATED: Pennsylvania
COUNTY LOCATED: Blair
STREAM: Sink Run, secondary tributary of the Little Juniata River
DATE OF INSPECTION: July 12 and 18, 1978

TYRONE RESERVOIR NO. 2
 NDI 1.D. NO. 535
 JULY 12, 1978

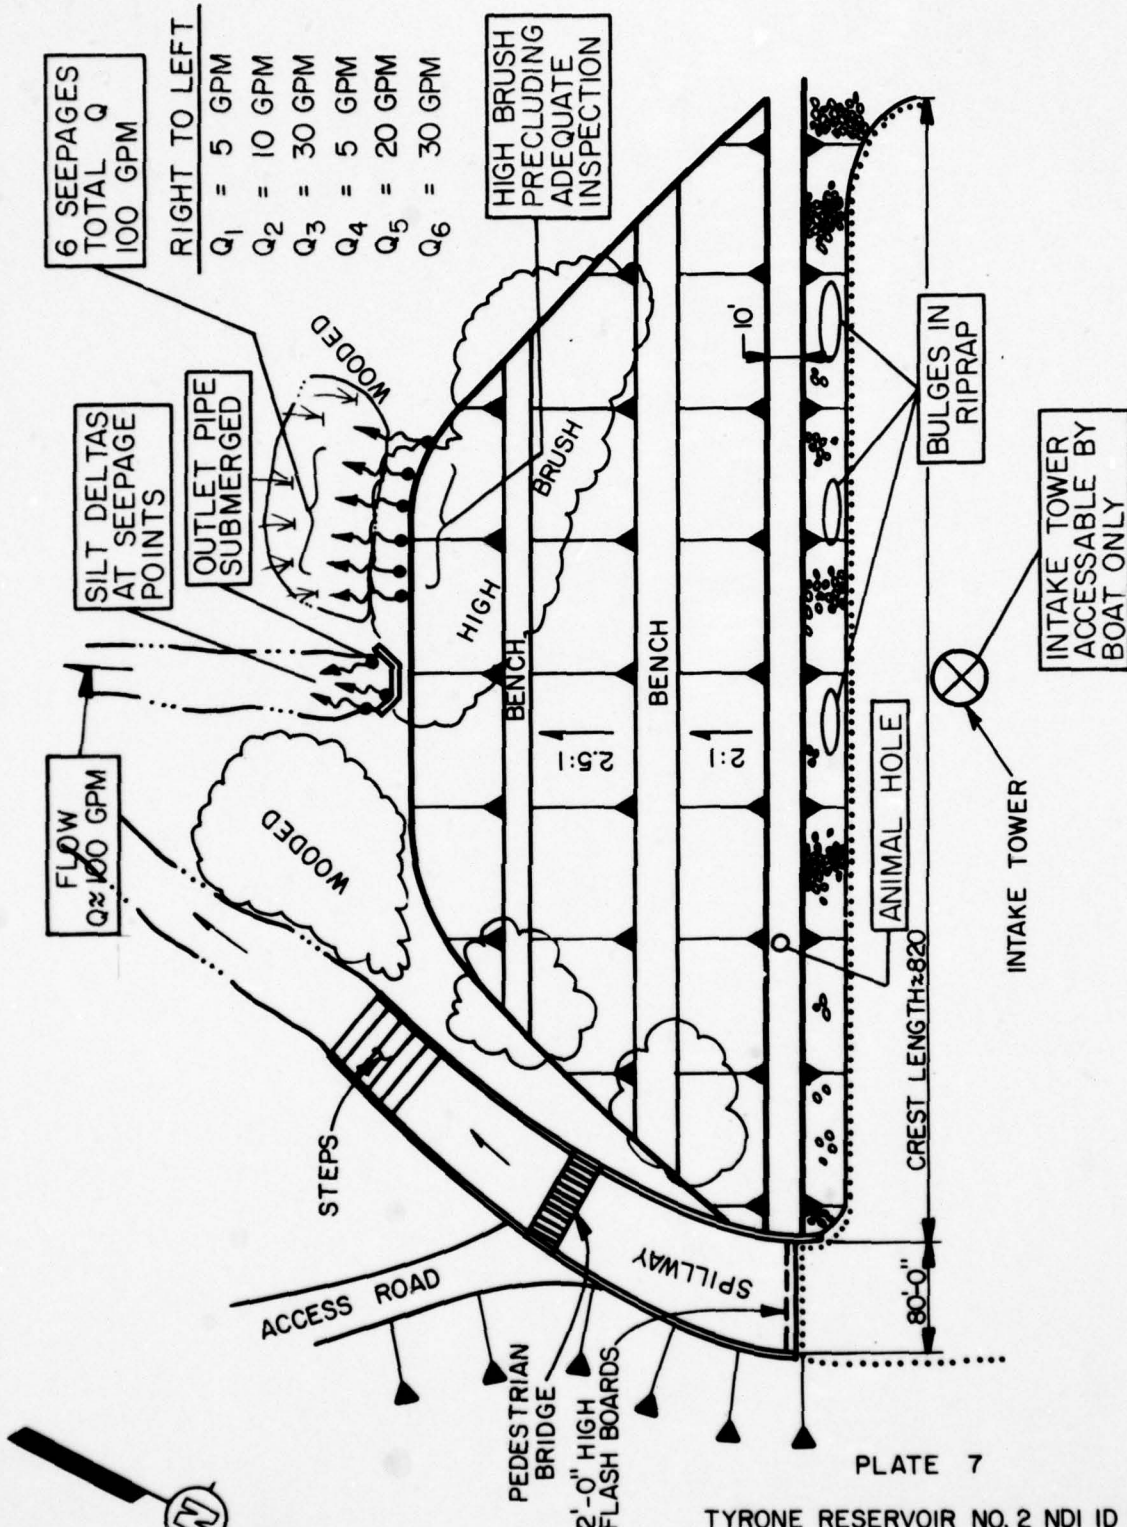
PLATE 7

The most significant problem at the site is the presence of numerous seeps along the toe of the dam, located on the right side of the blow-off pipe. At least six seepage points were observed. Estimated seepage flows ranged from 5 to 30 gallons per minute (Plate 7).

TYRONE RESERVOIR NO. 2 NDI ID 535
GENERAL PLAN
FIELD INSPECTION NOTES
FIELD INSPECTION DATE: JULY 12, 1978

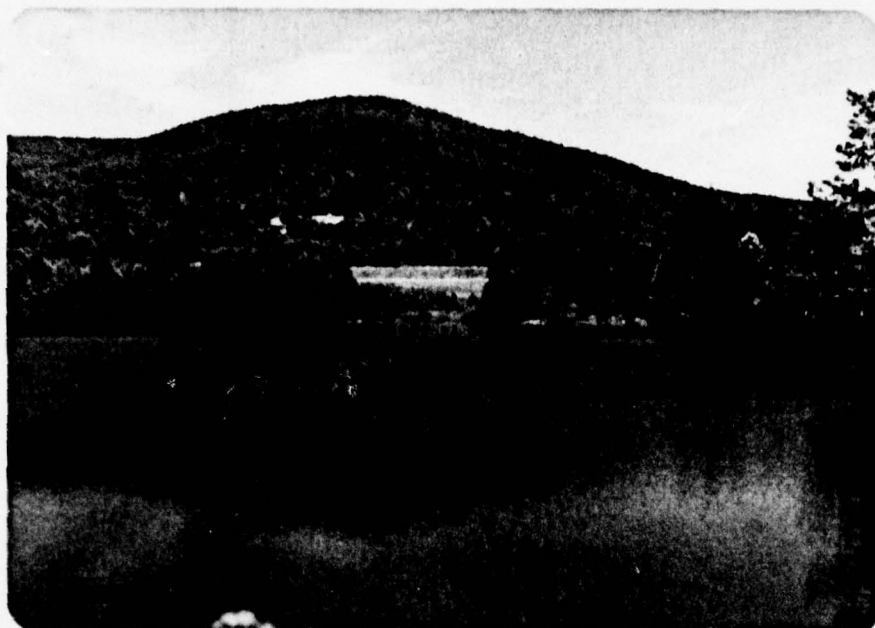
Photograph No. 1

Tyrone Reservoir No. 2 (background).
Tyrone Reservoir No. 1 (foreground).

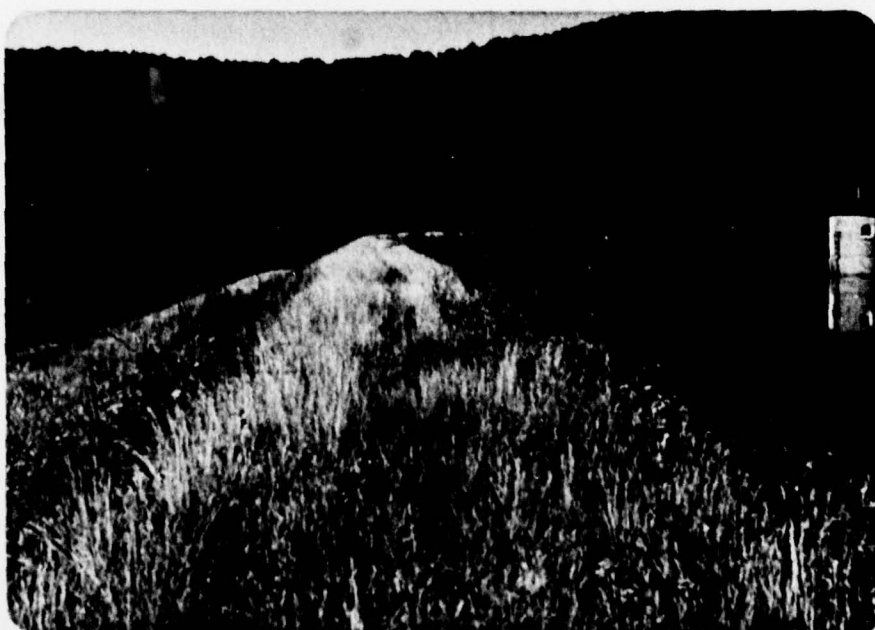
Photograph No. 2

Crest.

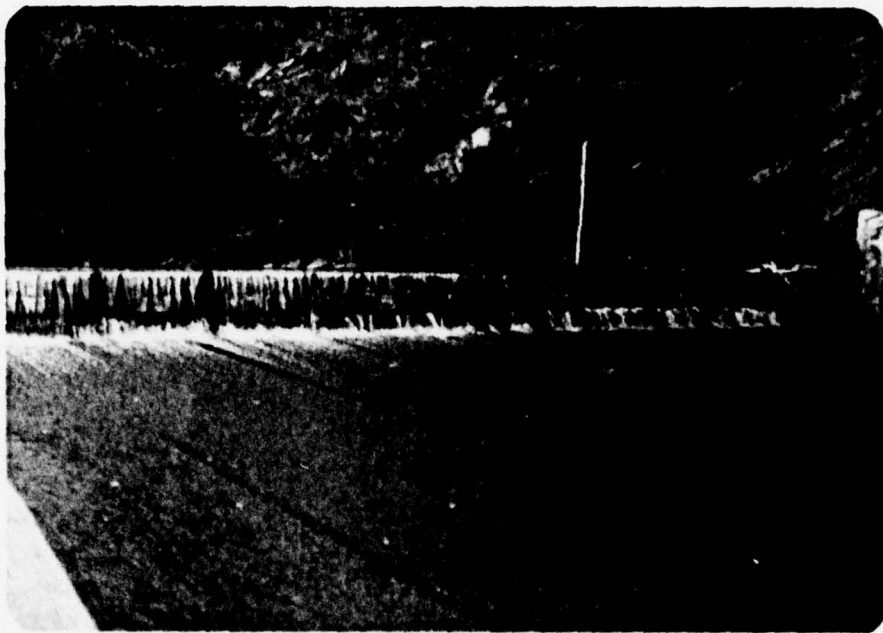
Photograph No. 3
Spillway crest (note flash boards).

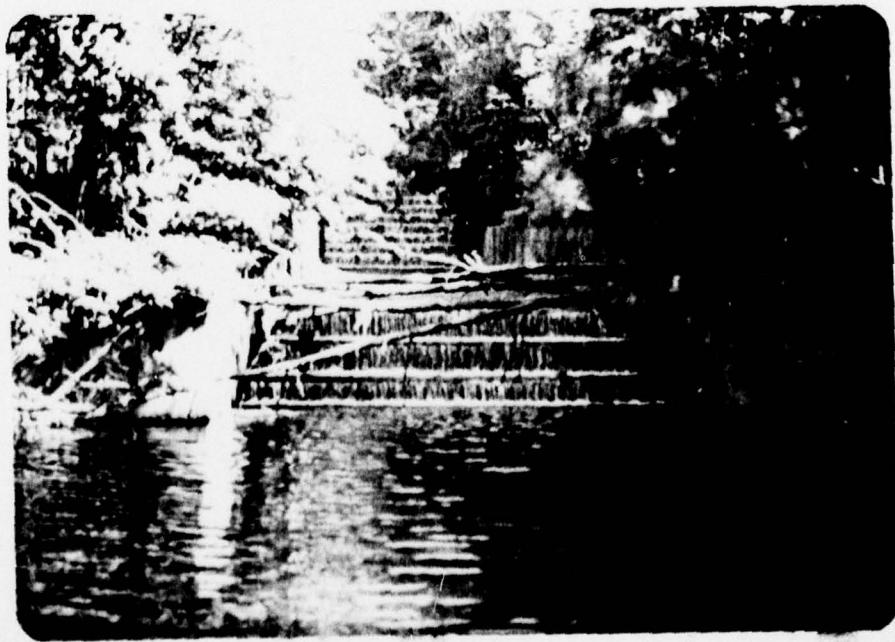
Photograph No. 4
Spillway discharge channel.

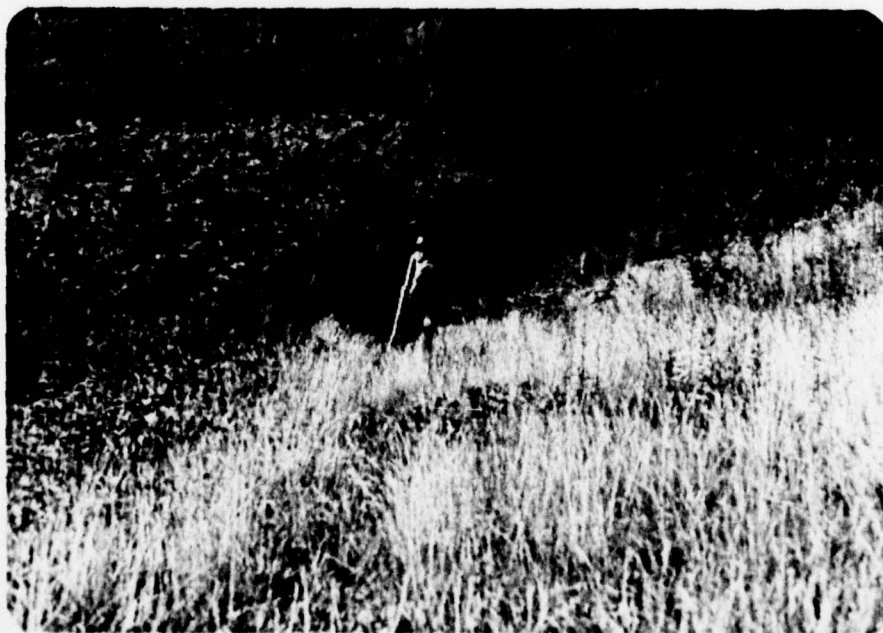
4.2 Maintenance of the Dam. The overall maintenance conditions of the dam are considered to be poor. Removal of the brush from the toe area and annual mowing of the grass is required.

Photograph No. 6
High brush on downstream slope.

3. Brush and trees should be removed from the downstream face of the dam and for a distance of at least 50 feet below the toe of the dam to permit adequate inspection of these areas in future inspections.
4. It is recommended that the owner should provide around-the-clock surveillance during unusually heavy runoff and develop a formal warning system to alert the downstream residents in the event of an emergency.
5. It is recommended that the owner be advised that the dam and appurtenant structures should be inspected regularly and necessary maintenance should be performed.
